# Laboratory test methods and results for double shear performance of Australian CT bolts in simulated strata

**ABSTRACT:** Australian CT Bolts are a strata support system used in major Australian tunnelling projects, engineered for a 100-year lifespan using the Double Corrosion Protection (DCP) system. Sandvik Ground Support (formerly DSI Underground Australia) has undertaken a series of comprehensive test programs on the Australian CT Bolts in collaboration with tunnel designers and construction companies. A major component of this work has been laboratory double shear tests, providing critical information on the deformation limits of the bolt for combined shear and tension. This paper discusses a program of laboratory double shear testing that was conducted on three types of Australian CT Bolts: the 310kN solid steel rebar, a 579kN solid steel rebar, and a 573kN steel strand cable bolt. The results from this test program provide evidence for a practical shear displacement limit for the Australian CT Bolt design.

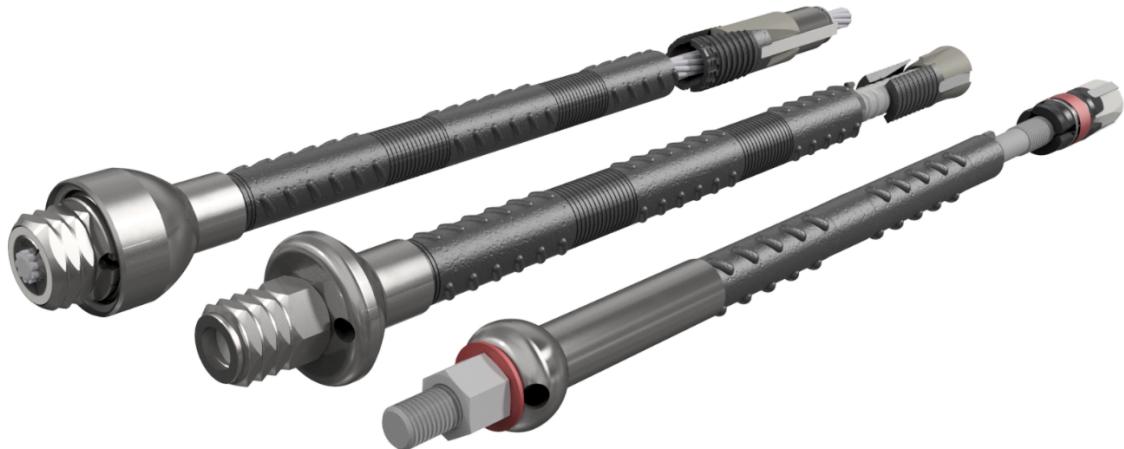
Figure 1. From left to right - DCPCB, CT26WR, and CT bolt

Three bolt types are discussed within this paper; the CT Corrosion Protected Mechanical Bolt (abbreviated hereafter as CT bolt), the CT High Strength Corrosion Protected Mechanical Bolt (abbreviated hereafter as CT26WR bolt) and the Double Corrosion Protected Cable Bolt (abbreviated hereafter as DCPCB) – the three bolt types are shown for comparison in Figure 1. For clarity, note that these bolt types are products of Sandvik Ground Support Australia. The internal steel tendon is the primary difference between each bolt type, each tendon having different mechanical properties; the CT bolt is a 310kN solid bar with a 21.7mm diameter high tensile steel rebar, the CT26WR bolt is a 579kN continuously threaded high tensile solid steel bar with 26.5mm diameter thread and the DCPCB contains a 573kN 21.8mm diameter nineteen wire steel strand cable bolt. The CT bolt uses a nominal 35mm diameter plastic sheath, while the CT26WR and DCPCB both use a nominal 45mm diameter plastic sheath.

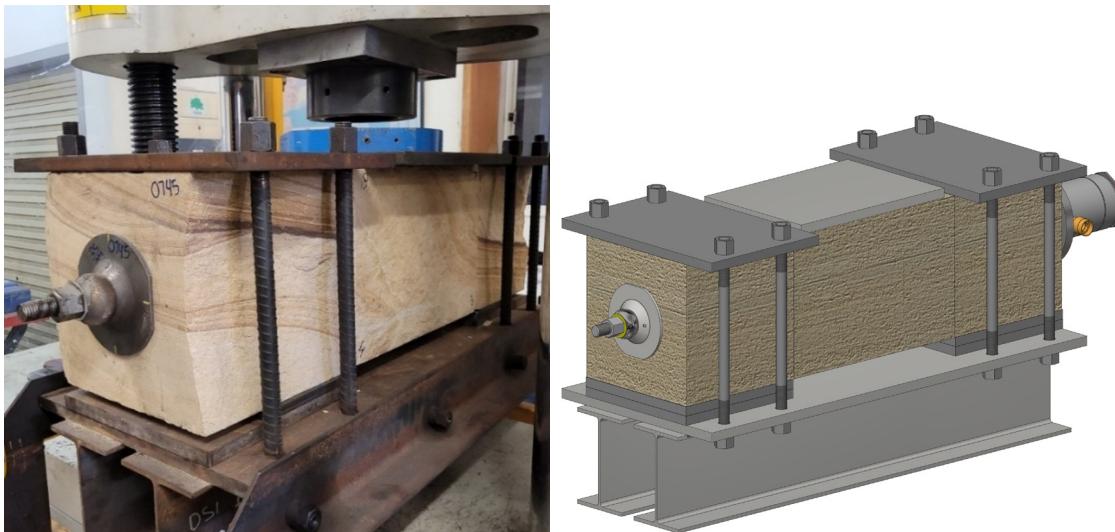
Figure 2. The left image shows test frame and machine prior to load testing, at the Sandvik ground support laboratory at Newcastle. The right image shows a graphic representation of the test sample and apparatus.

A double shear test method was used to apply a specific, pre-determined shear displacement across the rockbolt, as installed within the shear blocks. Full sized rockbolts were used for the testwork, along with shear blocks of strength and properties comparable to common strata conditions encountered within the relevant underground environment. A steel framework was used to house the shear block segments, allowing for accurate control and progressive measurement of shear displacement during each test. Shear forces were applied to the test samples using a calibrated universal test machine. After each test, the blocks were dissected and samples analysed to find the effects of shearing on the rockbolt. Figure 2 shows both a photo and graphic images of a test arrangement prior to shear loading.

A mechanical test frame was developed to house the three blocks (and installed test bolt) to permit the use of a universal test machine. The test frame consisted of a rigid solid steel frame, with packing plates and tensioning bolts to restrain the two end blocks while providing clearance for movement of centre block (see Figure 2).

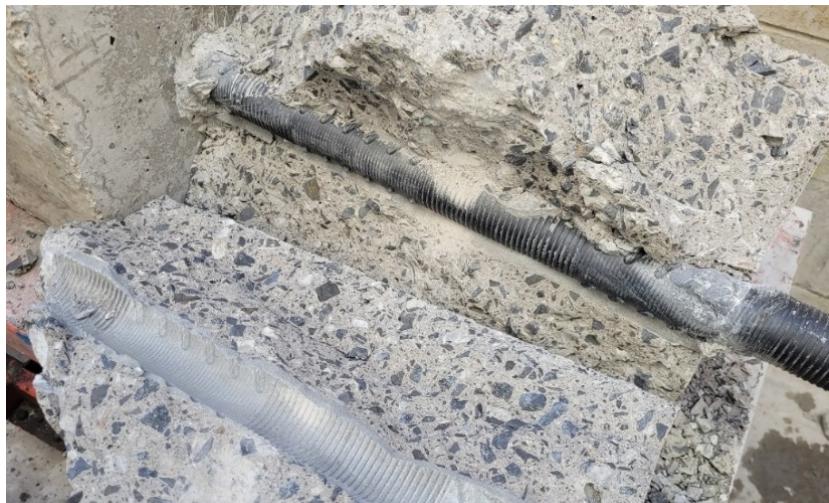
Figure 3. Initial sectioning of a CT26WR shear test sample after 20mm of shear. The centre block has been halved and opened, with the outer grout annulus remaining intact (lower left section), also revealing the bolt and sheathing (upper right section).

- The test blocks were cut using a concrete saw through to the centre grout and bolt element – see Figure 3. The conditions of the outer grout layer and the overall condition were subsequently documented.

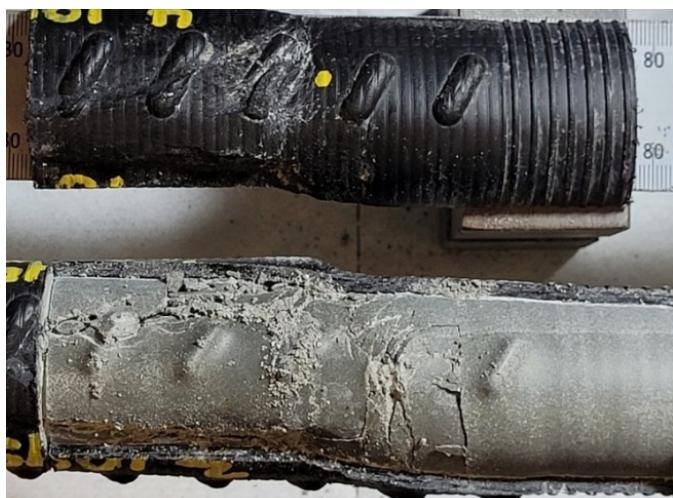
Figure 4. Sectioning of a tested CT26WR bolt sample at the shear plane, following 20mm of shear displacement. The inner annulus of cement grout has substantively held together during deformation of the bolt at the shear plane.

- Two 250mm long sections of the sheath were then removed from the bolt, one from each of the two shear plane regions. Removal of the sheath enabled visual inspection of grout coverage within the inner annulus and was photographed at each location (see Figure 4 as an example).

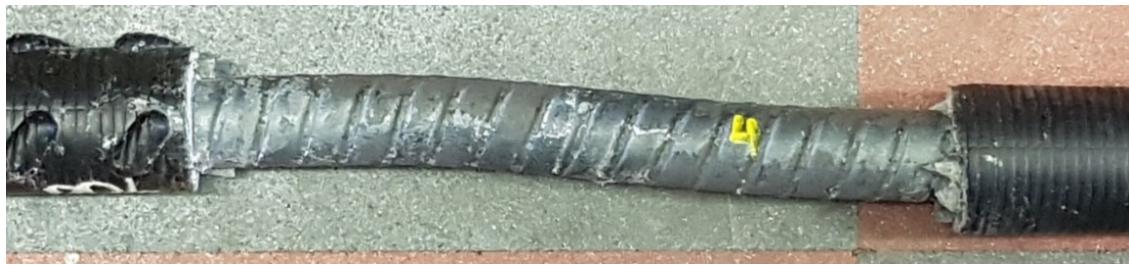
Figure 6. An example of a bolt, taken at the shear plane, following loading to 20mm shear displacement test.

- The final stage was to measure the steel tendon for bending. Measurements of the axial offset of the tendon centre portion were taken using a rule and square. An example of this axial offset is shown in Figure 6.

Damage to the steel tendon from shear testing was less severe than anticipated. The permanent bend within the steel tendon would increase proportionately with shear displacement, with the 35mm shear displacement tests showing the highest amount of bend. The amount of permanent elongation for all steel tendon types suggested the shear stress applied to the tendon was well below its ultimate strain and material strength. For both the CT and CT26WR bolt tests, the final displacement of the steel tendon sample did not match shear blocks test displacement. The strongest evidence for the difference in observations is due to the compressive fracture of the block and grout material at the shear planes. Compression of the block and grout caused shear forces to disperse across the steel tendon and resulted in the S-shaped bend within the tendon.
