## Tawhai tunnel lining recovery

S.F. Chau, T. Cheung  
Aurecon, Auckland, New Zealand

**ABSTRACT:** Tawhai Tunnel, located on KiwiRail's Stillwater–Ngakawau Line (SNL) on the West Coast of New Zealand's South Island, was constructed in 1891 and is 373m long. Its tunnel lining system consists of a 250 to 400 mm thick concrete sidewall extending to the tunnel spring-line and a single-layer, 250 mm thick concrete block arch forming the tunnel crown. In mid-June 2024, the 133-year-old tunnel had three sections of tunnel lining fail. Immediately following the event, KiwiRail established a multi-disciplinary tunnel recovery team, comprising the Client (KiwiRail), Design Consultants, and Contractors. This team worked collaboratively to restore the tunnel safely, efficiently, and to a high-quality standard within a short timeframe. The recovery design and construction work were completed within 26 weeks, and the tunnel reopened for coal train operations on 12 January 2025. This paper provides a brief overview of the tunnel's construction history. Based on site observations, it also discusses the back-analysis undertaken to determine geotechnical analysis parameters plus the design and c

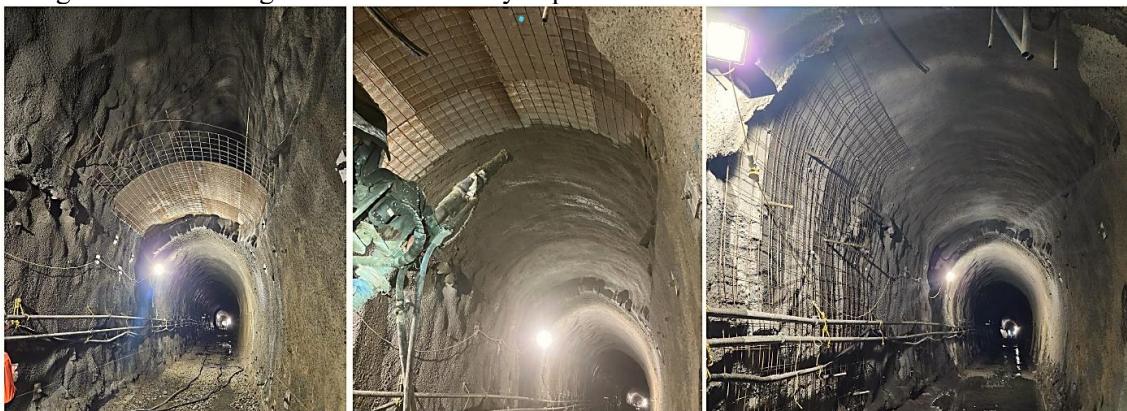
For the recovery of the FOG, an initial thickness of shotcrete was applied to the roof cavern to stabilise the exposed ground and restore the ground support conditions for safe entry. To rebuild the tunnel structure and re-establish ground arching, Tek mesh was installed around the new arch for the initial shotcrete application. Reinforcing bars, spaced at 1 m intervals, were bent to improve the mesh stiffness. Reinforced mesh was then bent and installed onto the bars. Tek mesh was clipped to the reinforcement mesh to ensure good adhesion of the shotcrete. The mesh was positioned above the existing tunnel profile to allow sufficient thickness for the development of a new arch, approximately 400 to 500 mm thick. The remaining void above the newly formed lining was filled with grout and low-density expansive concrete.

Figure 7. Fall of Ground (FOG) crossing works.

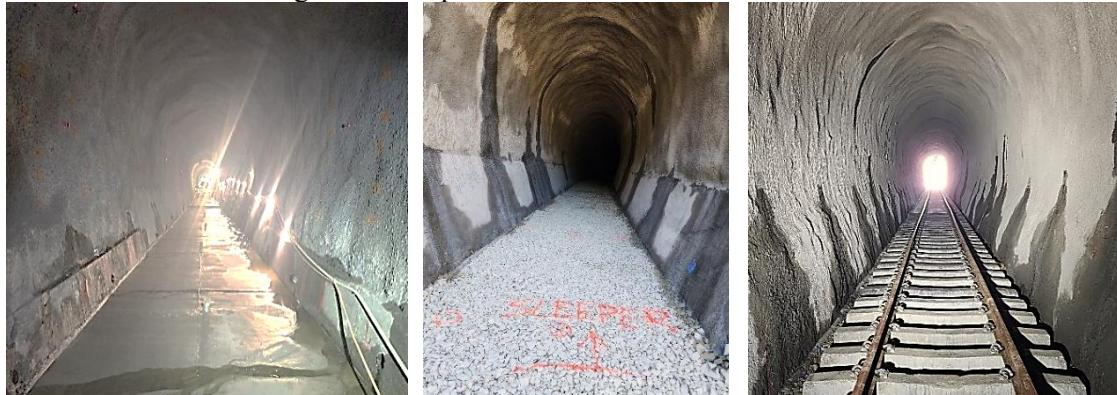
Figure 9. Repaired SNL tunnel 1.

The recovery design and construction work were completed within 26 weeks, with the tunnel reopening for coal train operations on 12 January 2025. Robotic machines applied approximately 950 m<sup>3</sup> of concrete to reinforce the tunnel lining. A total of 886 rock bolts were installed to anchor the lining to the surrounding ground. Additionally, about 373 m of modern concrete tunnel lining and a new track bed drainage system were installed.
