The Blue Mountains Route Clearance Project – tunnel lining modifications for the Ten Tunnels Deviation

C.K. Bodner & R.M. Gibson

Aurecon Australasia Pty Ltd, Sydney, Australia

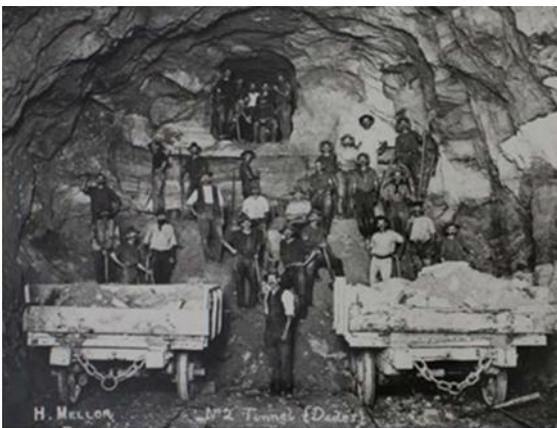
Figure 5. Pilot, heading and bench excavations. Note rough tunnel profile with large over-break. Source: Lithgow History Avenue c. 2010.

Tunnel excavation was undertaken using drill and blast methods. This involved the excavation of a short pilot heading followed by a heading enlargement and finally benching (Fig. 5). The photographs indicate that no temporary support was installed during these excavations. As the tunnel advanced, the rough drill and blast profiles in the heading and bench were manually scaled and smoothed to achieve the required horseshoe profile (Fig. 6). Overbreak above the springline was backfilled with tunnel spoil or bricked out during construction of the tunnel lining (Fig. 2). The treatment of overbreak was an important consideration when developing design loadings for the tunnels.

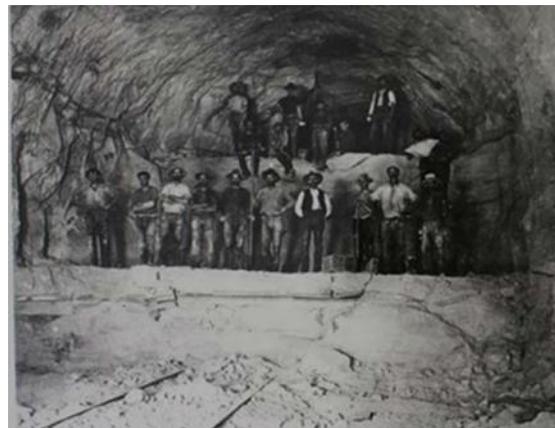
Figure 6. Heading and bench excavations. Note manual scaling of heading excavation profile.

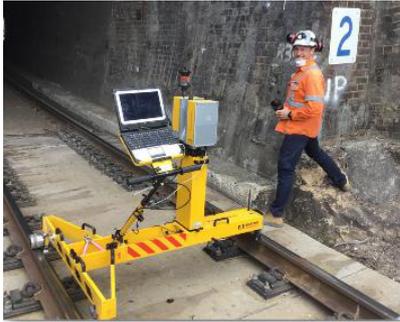
Figure 10. Amberg survey trolley.

The NIF infringements were located using the Amberg rail trolley (Fig. 10) which is a highly accurate laser scanning device guided by a total station. A digital version of the required KE was used by the Amberg trolley to identify and measure the NIF infringements. The infringements were recorded and could also be viewed in real time which was particularly useful during construction.

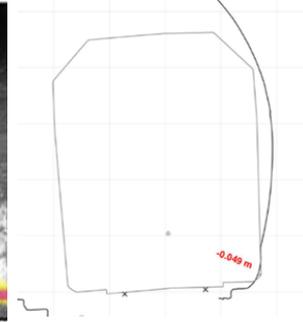
Figure 12. Example of survey infringement in cross section.

Infringement cross sections (Fig. 12) were developed at one metre intervals. Figure 12 shows the lining thickness reduction at the toe originating from the previous modifications referred to in §3.

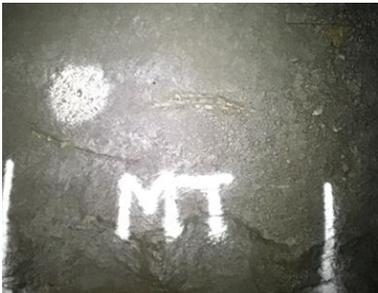
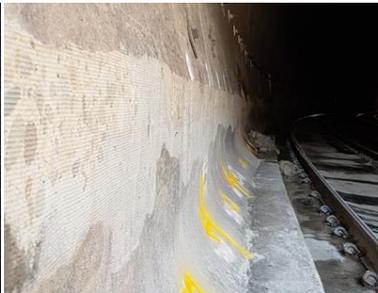
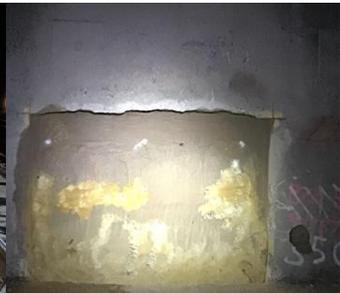
Table 2. Differences between the nominated treatment types in concrete.

Trimming with handheld tools/equipment for localised KE infringements up to 50 mm depth only.	Applies where $t_{\text{residual}} > t_{\text{min.c}}$ Trimming using wall shaver or rotary milling head attached to an excavator. Image shown after wall shaving.	Applies where $t_{\text{residual}} \leq t_{\text{min.c}}$ Excavation through the brick or concrete wall into rock to achieve a minimum panel thickness required for structural plinth support

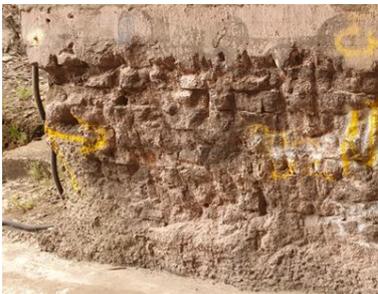
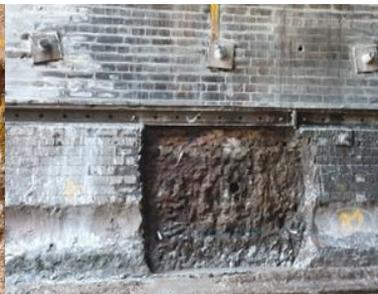
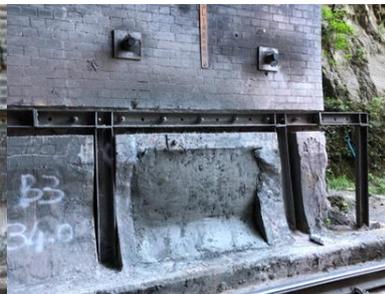
Table 3. Differences between the nominated treatment types in brick.

Trimming with handheld tools/equipment for localised KE infringements up to 50mm only.	Where $t_{\text{residual}} > t_{\text{min.b}}$ Wall shaver or rotary milling head. Mortar repointing as required. 50 mm thick shotcrete panel.	Where $t_{\text{residual}} \leq t_{\text{min.b}}$ Hit and miss sequence. Use of temporary steel frame installed with hand tools.

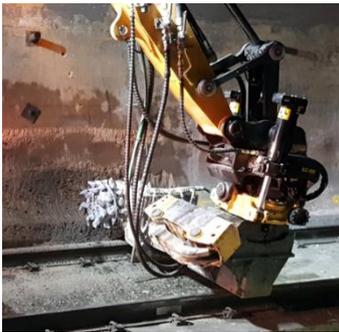
Figure 21. Rotary milling head attachment. Note size of cutting teeth and roughened wall profile.

The rotary milling head demonstrated significantly higher productivity in terms of square meters per hour compared to diamond-edged discs. It could also be positioned much closer to the toe during trimming. However, its precision was inferior due to the large cutting teeth, which often dislodged river stone aggregate from the original concrete wall. This resulted in a rougher surface profile increasing the risk of rework due to residual infringements. Notwithstanding this, the finish was no worse than the finish achieved during prior modifications.

For underpinning treatments in concrete, the rotary milling head attachment (Fig. 21) was used. Machine guidance wasn't as critical in underpinning areas as the work area was isolated and offsets to the desired depth could be set out and monitored by the operator.

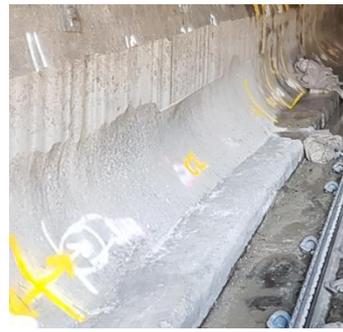
Figure 22. Wall trimming with a diamond disc drum (light grey). Note smooth but undulating surface.

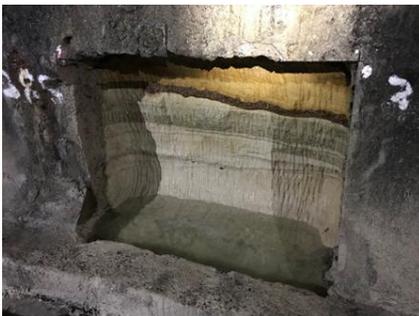
Figure 23. Water ponding after underpinning excavation.

In Tunnels 1 and 10 significant seepage water ingress had to be managed, which posed a risk for underpinning and concreting works. Where water ponding occurred at the base of the panel (Fig. 23), a drainage relief slot was cut into the existing concrete plinth to drain the water (Fig. 24). Drainpipes connected to a drainage mat at the back of the excavation ran through this slot to permit permanent seepage water discharge into the tunnel drainage system. This was particularly important in areas of running groundwater inflow to ensure that the shotcrete was not placed against running or into ponding water, which would have likely resulted in defective concrete. The slot was finally backfilled and trowelled off during concreting of the main panels.
