Primary support installation for the Albert Street Station cavern and main station entry shaft intersection, Cross River Rail, Brisbane

R.Elliott, D.Keating
SYSTRA ANZ, Brisbane, Australia

ABSTRACT: As part of the Cross River Rail (CRR) project in Brisbane, the Albert St Station mined cavern was one of the most technically complex underground structures. Constructed beneath the city's central business district (CBD), the cavern featured a critical junction that connected two pedestrian adits and a services adit directly to the main station entry shaft. Excavation and support activities were constrained by limited site access, proximity to adjacent basements, and the requirement to maintain ground stability in challenging geotechnical conditions. This paper outlines the primary ground support design, construction staging and highlights key lessons learnt.

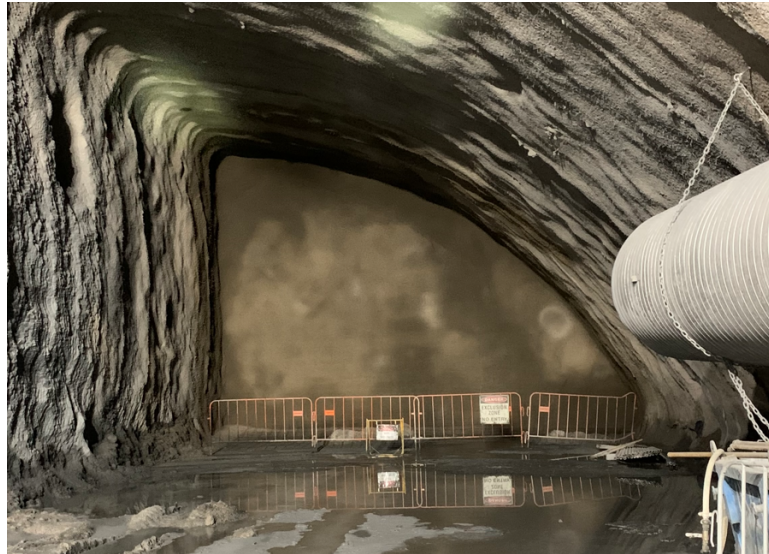
Figure 3. Typical signage and barrier set up in cavern

Safety measures on site included controlling unsupported ground with signage and barriers to inform personnel of hazardous areas. A typical signage and barrier set up is shown below in Figure 3. Ventilation and dust control were managed using three dust scrubbers in the Albert St cavern, with one servicing the south and two servicing the north. To ensure safe people-plant interaction, dedicated personnel walkways were delineated from tunnel plant using crowd control barriers, and no personnel were allowed in front of the rear jacks of the bolting rig. The delivery team maintained safety through weekly safety task observations and inspections. Quality control measures included rock bolt pull testing and shotcrete testing using cylinders and sprayed panels. A challenge faced was ensuring that the panels remained in an area free of potential damage for at least 24 hours.

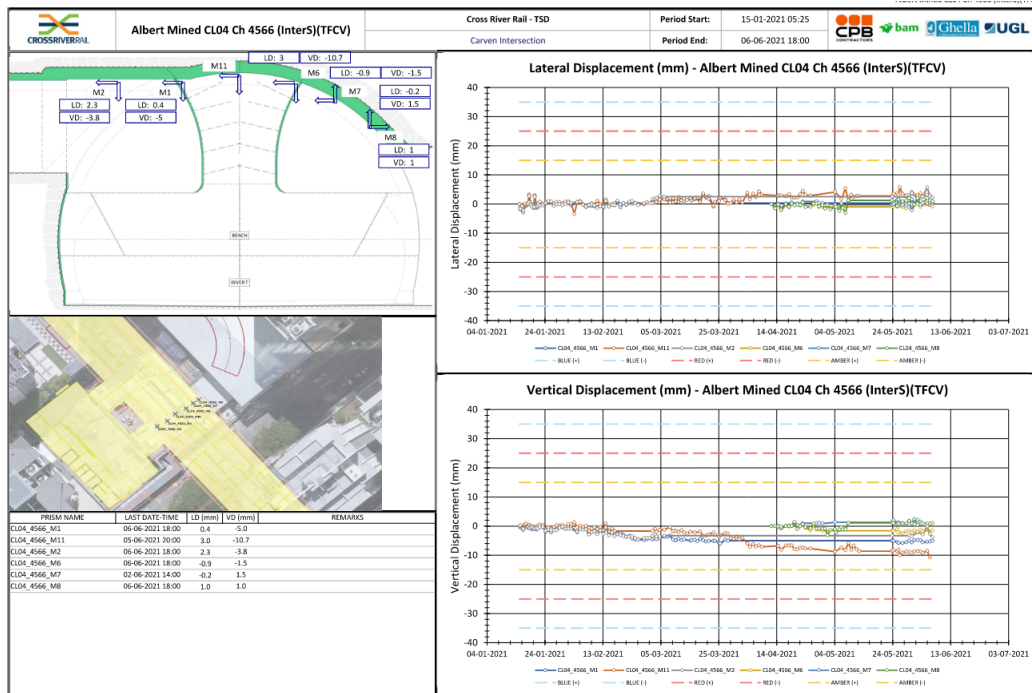
Figure 7. Example monitoring data reviewed during Albert St tunnel permit to tunnel meetings

Due to the location of the Albert St Station cavern, it was determined that a daily permit to tunnel (PTT) would be employed to ensure a comprehensive review of the previous 24 hours of excavation activities. This meeting would assess and interpret ground monitoring data and instrumentation results, confirm alignment with design predictions and allowable limits, and determine and agree on the excavation and ground support for the next 24 hours. Key areas of monitoring included the Albert St footpath between Mary St and Charlotte St for surface settlement, the Sebel Hotel and Festival Towers, which were neighboring high-rise buildings to the junction construction, monitored for displacement and tilt, and in-tunnel monitoring where survey targets were required to be installed in arrays every 10 metres through this junction area as per the design. The design drawings stipulated trigger levels for each type of monitoring instrument depending on location and support type. An example monitoring graphs that were reviewed daily in the PTT are given in Figure 7 below.

If the trigger action levels were breached, a Management Action Team or 'MAT' meeting was called. In total, 40 MAT meetings were held during the full cavern construction program, with 9 occurring during the period of the junction top heading construction. Of these, 3 were due to surface settlement alarms on the Albert St footpath above, with a maximum settlement of 12mm recorded during this time. Tiltmeters on Festival Towers caused a red alarm during this period, but it was concluded that there were no major issues as the tiltmeter sensors were very sensitive to rain events. The construction of the junction top heading took place in summer, a season characterized by frequent rain in Brisbane. In summary, the design predictions on ground, tunnel, and building movement were all within design expectations.

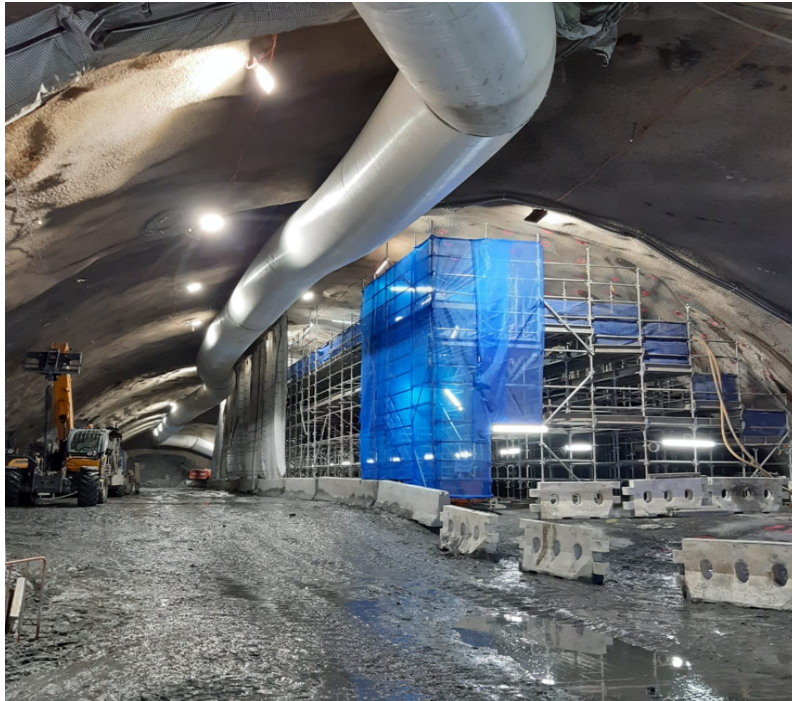
Figure 8. Scaffold erection in constrained top heading

Due to the major design constraint of the adjacent main station entry shaft, after completing the cavern top heading excavation and Stage 1 primary support, it was necessary to install extrados and intrados layers of reinforcement, with shotcrete layers applied to encapsulate the reinforcement. Rebar was utilised in TH1 with top and bottom mesh to be installed in TH2 and in the central heading. Stremaform (a stay-in-place formwork) was installed at the intersection of the headings to create a construction joint. The sequence of works to complete the junction reinforcement followed these steps: preparing the scaffold area, erecting the scaffold, installing anchors for dummy bars, setting dummy bars, installing and tying extrados reinforcement, removing the scaffold and storing it underground, applying shotcrete to the passive lining, re-erecting the scaffold, installing and tying intrados reinforcement, removing the scaffold, and finally, shotcreting the remaining passive lining. The main purpose of utilizing a scaffold instead of scissor lifts for the rebar installation was due to several reasons: it enabled a stable working platform, productivity was assumed to be quicker than with a scissor lift, and it minimised the potential for slips and trips. Refer to Figure 8 for as built photo of the scaffold. Interface management was crucial during this stage, as the adjacent AA4 adit was to be excavated simultaneously with the reinforcement installation. Therefore, the scaffold structure had to be protected from plant interaction, which was achieved by using pinned-down concrete barriers directly next to the scaffold structure.
