Application of geospatial data and Artificial Intelligence in underground infrastructure development near existing structures

H. Wang & A. Rawlinson
WSP Australia, Sydney, Australia

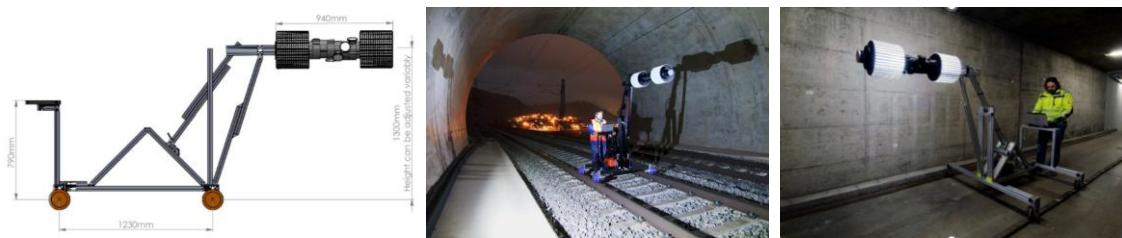
Figure 3. Vehicle-mounted tunnel scanning system equipped with laser profiler and DSLR cameras for 360° image and geometry capture.

The tunnel scanning system shown in Figure 5 collected LiDAR and photogrammetry data at a spatial resolution of 1 mm × 1 mm, with colour imagery captured via digital single-lens reflex (DSLR) cameras at up to 50 megapixels. Point cloud registration to survey control utilised iterative closest point (ICP) algorithms, achieving sub-centimetre alignment accuracy. Data acquisition was completed during two tunnel access windows of approximately 2.5 hours. Raw point clouds were denoised, segmented, and meshed to create high-fidelity 3D models, consistent with methods applied in recent mobile laser scanning frameworks for tunnel environments (Liu et al., 2024). These datasets were then converted to .las, .obj, and .shp formats for integration with Computer-Aided Design (CAD) objects or Building Information Modelling (BIM) software and asset management databases. Geospatial metadata, including tunnel chainage, invert level, and station location, were tagged to each segment, enabling spatial filtering and time-based defect tracking during future inspections.

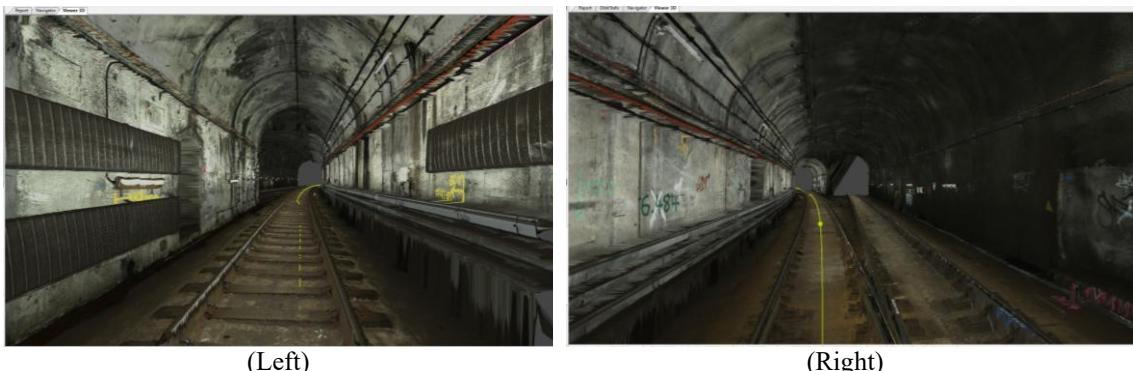
Figure 4. 3D reconstruction of tunnel lining using Dibit8 software. (Left) Colour-mapped mesh of the Down Track tunnel surface. (Right) Crown region showing darker-coloured 2004 shotcrete overlay compared to the original 1971 lining.

The tunnel condition assessment demonstrated several practical benefits for infrastructure monitoring and dilapidation surveys. Approximately 190 m of rail tunnels were scanned, capturing geometric details and spatial data, as depicted in Figure 4.

Photogrammetric models provided accurate visual representations of tunnel surfaces, while defect mapping for corrosion, leakage, and cracking was carried out using Dibit8 software. The software also mapped tunnel features, including emergency doors, lights, and service cables. The Down Track tunnel exhibited localised expansion and crown deformation. Figure 4 (Right) illustrates the darker coloured shotcrete applied in 2004, distinguishable from the original 1971 lining through AI-assisted 3D scanning and analysis. This diagnostic capability demonstrates enhanced accuracy compared to conventional inspection methods.

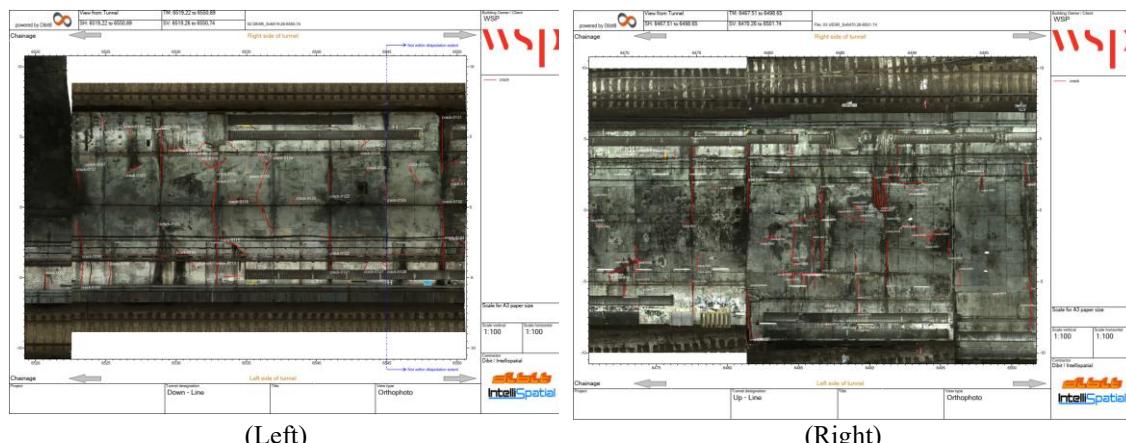
Figure 6. Plan layout of tunnel dilapidation survey results. (Left) Down Track tunnel. (Right) Up Track tunnel. Annotated defects mapped using AI-assisted 3D scanning.

The Dibit8 software processed the tunnel data into true-colour 3D point clouds and textured 3D mesh models exported in various data formats (e.g., .las for LiDAR point cloud, .obj for the photogrammetric model, .shp for integration with CAD and BIM software. Bentley OpenRail software was subsequently used to import point cloud files, generate a 3D track alignment model, produce 3D track alignment models and cross-sections, and export tunnel geometries for instrumentation planning (Figure 5). The tunnel dilapidation survey is shown in Figure 6, with Down Track and Up Track tunnels demonstrated in the left and right layouts.
